Application Note

# Providing Quick and Easy Quality Control to the Polymer Industry Using the SQ Detector 2

This application brief demonstrates the utility of an SQ Detector 2 for clear and simple Quality Control (QC) monitoring of polymer additive blends, and to rapidly identify out of specification batches.

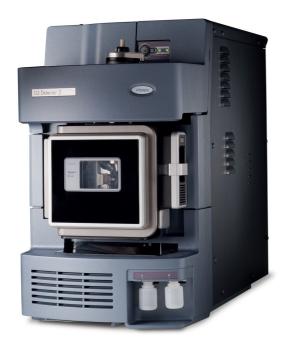
A Waters SQ Detector 2 with an Atmospheric Pressure Photo Ionization (APPI) source, coupled to an ACQUITY UPLC System, were used to acquire QC data for a blend of five polymer additives. The blend was comprised of: A. an antioxidant, Irganox 245; B. a UV absorber, 2-Hydroxy-4-(octyloxy)- benzophenone; C. a

plasticizer, Diethylhexyl phthalate (DEHP); D. a slip agent, Erucamide; and E. an optical brightener, Uvitex OB.

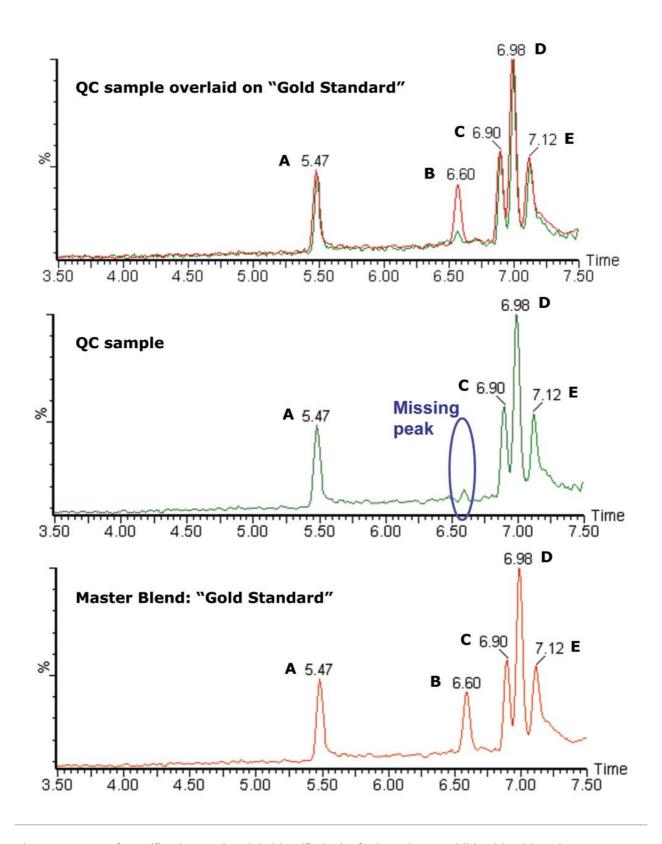
Figure 1. An out of specification QC batch is identified. The faulty polymer additive blend has the UV absorber 2-hydroxy-4-(octyloxy)-benzophenone missing and cannot be used in its current formulation.

Figure 1 shows a QC sample matched to a master blend "Gold Standard". The Gold Standard represents the correct analytical profile of the polymer additive blend. The QC data can be overlaid on the Gold Standard data to see if the batch is of acceptable quality. In Figure 1, the QC spectrum clearly has one component peak missing and no unexpected peaks are observed. Here the blend only has four of the five required components – the UV absorber is missing. The QC technician can quickly identify that the batch is out of specification, and that the missing component is vital to the correct performance of the additive blend. In this case, the manufacturing run using this faulty batch can be stopped and corrective action can be taken.
